ATTENTION RESIDENTS

Public Notice

A potential issue has been brought to our attention concerning the clamps on COPPER pipes leading to the water meters and the risk of potential corrosion.

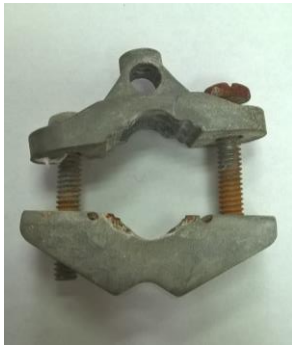
*This is a STEEL clamp
which can lead to
corrosion of COPPER
pipes and possible
leaks*

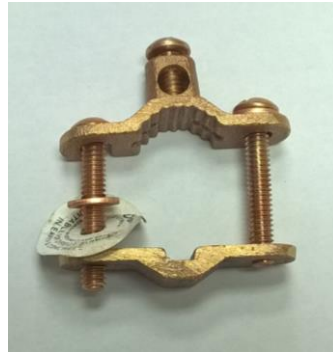
*This is a BRASS clamp
recommended for all
COPPER pipes.*

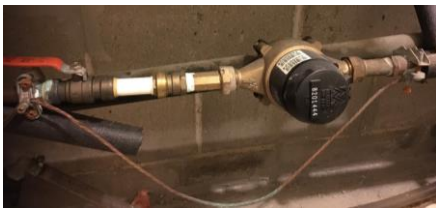
*Clamps can be seen either side
of water meter*

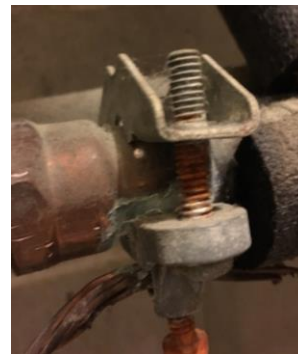
*Copper pipe showing
signs of corrosion*
